PHOTOGRAPHIC INTELLIGENCE REPORT

PROBABLE TANK/ASSAULT GUN REGIMENT

SHA-LI-TU MILITARY

COMPLEX-CHINA

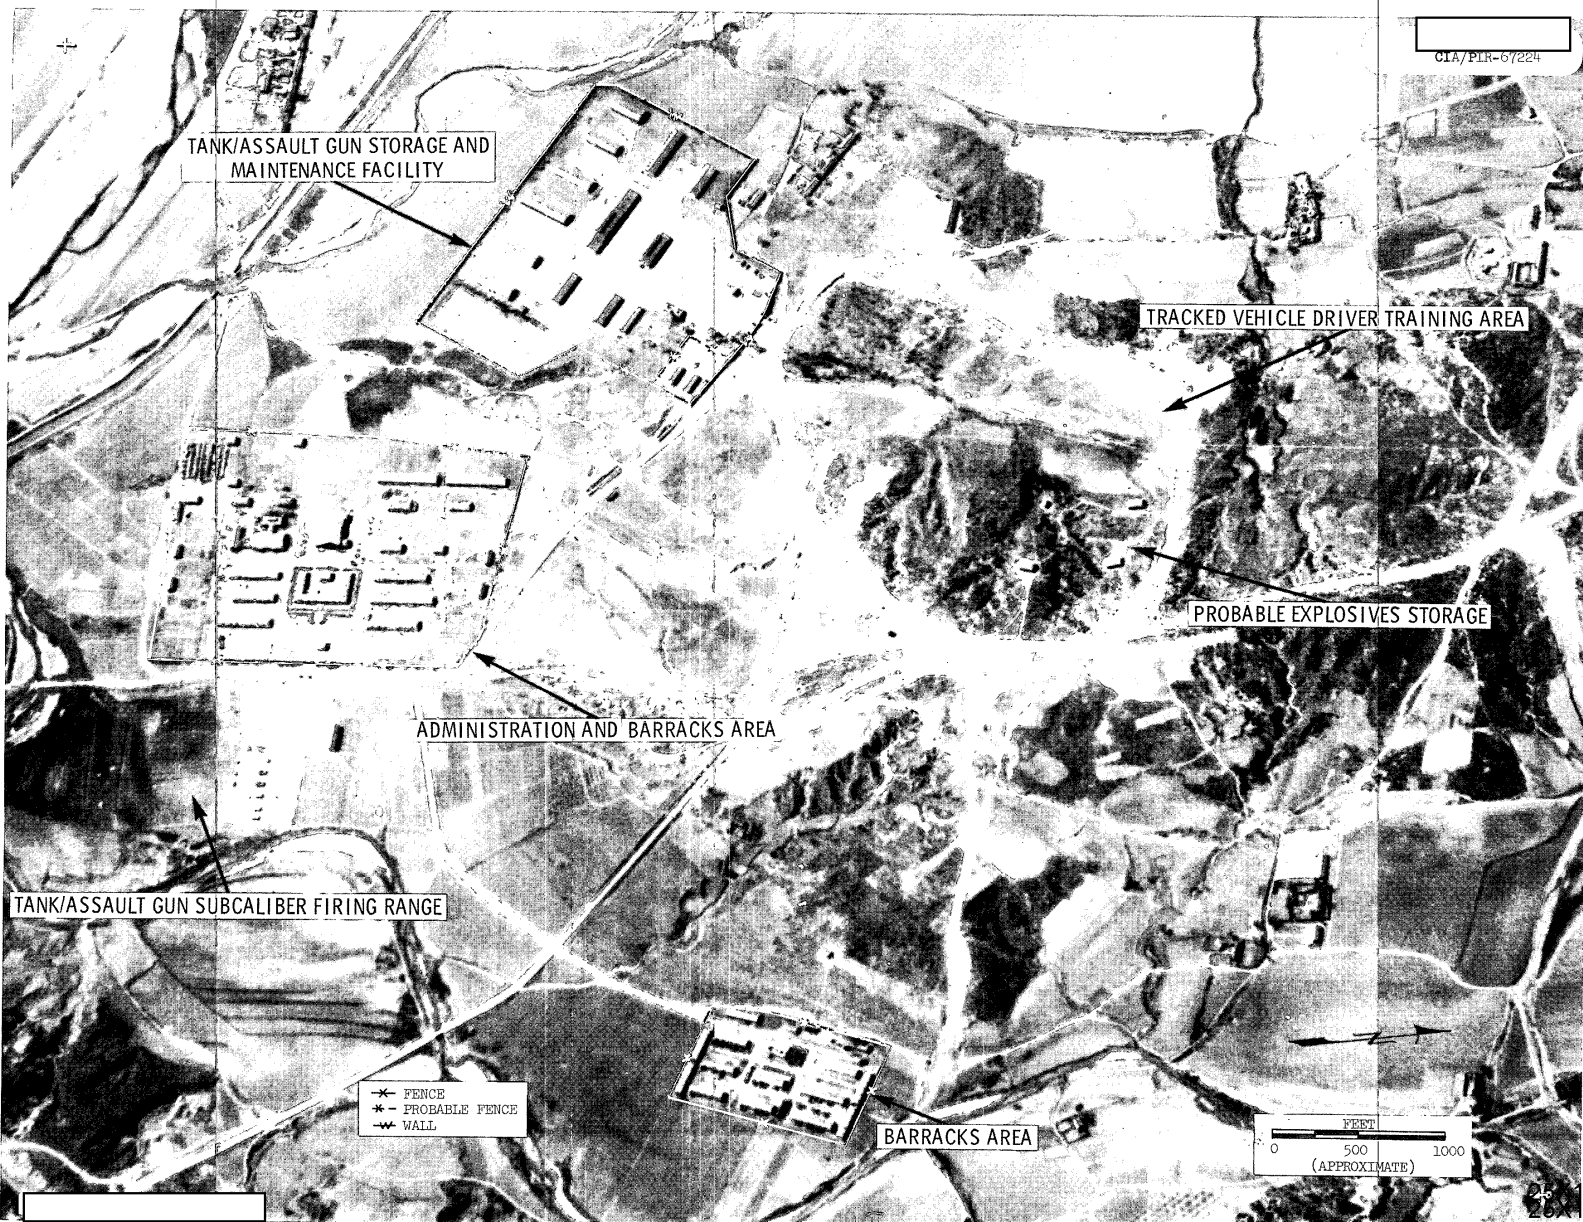
FIGURE 3

FUNCTIONAL AREAS (Figure 3)

I. Tank/assault gun storage and maintenance facility

- 2 Drive-through maintenance buildings
- 9 Vehicle storage buildings

- 2 Probable vehicle storage buildings
- 2 Probable general storage buildings
- 1 Probable heat/power plant
- 5 Support buildings
- 4 Grease racks

II. Administration and barracks area

- 8 Barracks (single story)
- 3 Probable quarters
- 1 U-Shaped single story administration building
- 1 Auditorium
- 1 T-Shaped messhall
- 3 Probable livestock sheds with pens
- 2 Support buildings associated with the livestock sheds
- 14 Support buildings

III. Barracks area

14 Barracks (single story)

- 1 Probable administration building (single story)
- 2 Support buildings

IV. Probable explosives storage area

4 Probable explosives storage buildings

V. Tracked-vehicle driver training area

2 Driver-training obstacles are located on the course

VI. Tank/assault gun subcaliber firing range

1 Probable range maintenance building

The tank/assault gun storage and maintenance facility is secured by a wall. The general storage area within the facility is separately secured by a probable fence. The administration and barracks area and the other barracks area are secured by fences. No security measures are observed at the probable explosives storage area or at the range area.

The only vehicles or pieces of equipment observed on [redacted] photography are 6 tanks/assault guns (4 of which are canvas covered) at the firing range. Six unidentified objects are located immediately in front of the tanks/assault guns. Photography of [redacted] revealed 2 probable tanks/assault guns at the subcaliber firing range.

The driver training area and the subcaliber firing range appear moderately active on all coverage. Scarring in the vehicle storage and maintenance facility indicates that the facility has been undergoing a moderate degree of usage. The barracks areas appear well maintained and occupied. No change to any of the facilities is observed from [redacted]
